# ENGINEERING TEST REPORT

ETR - 924

TITLE: Test Results of the RAH-66 Main Rotor Ballistically Damaged Flexbeam  
DATE: 4 August 1997  
A/C SERIES: RAH-66  
A/C MODEL: RAH-66 Prototype  
SYSTEM: Main Rotor  
CHARGE NO: CB571-300  
CONTRACT NO: DAAJ02-97-M-0001

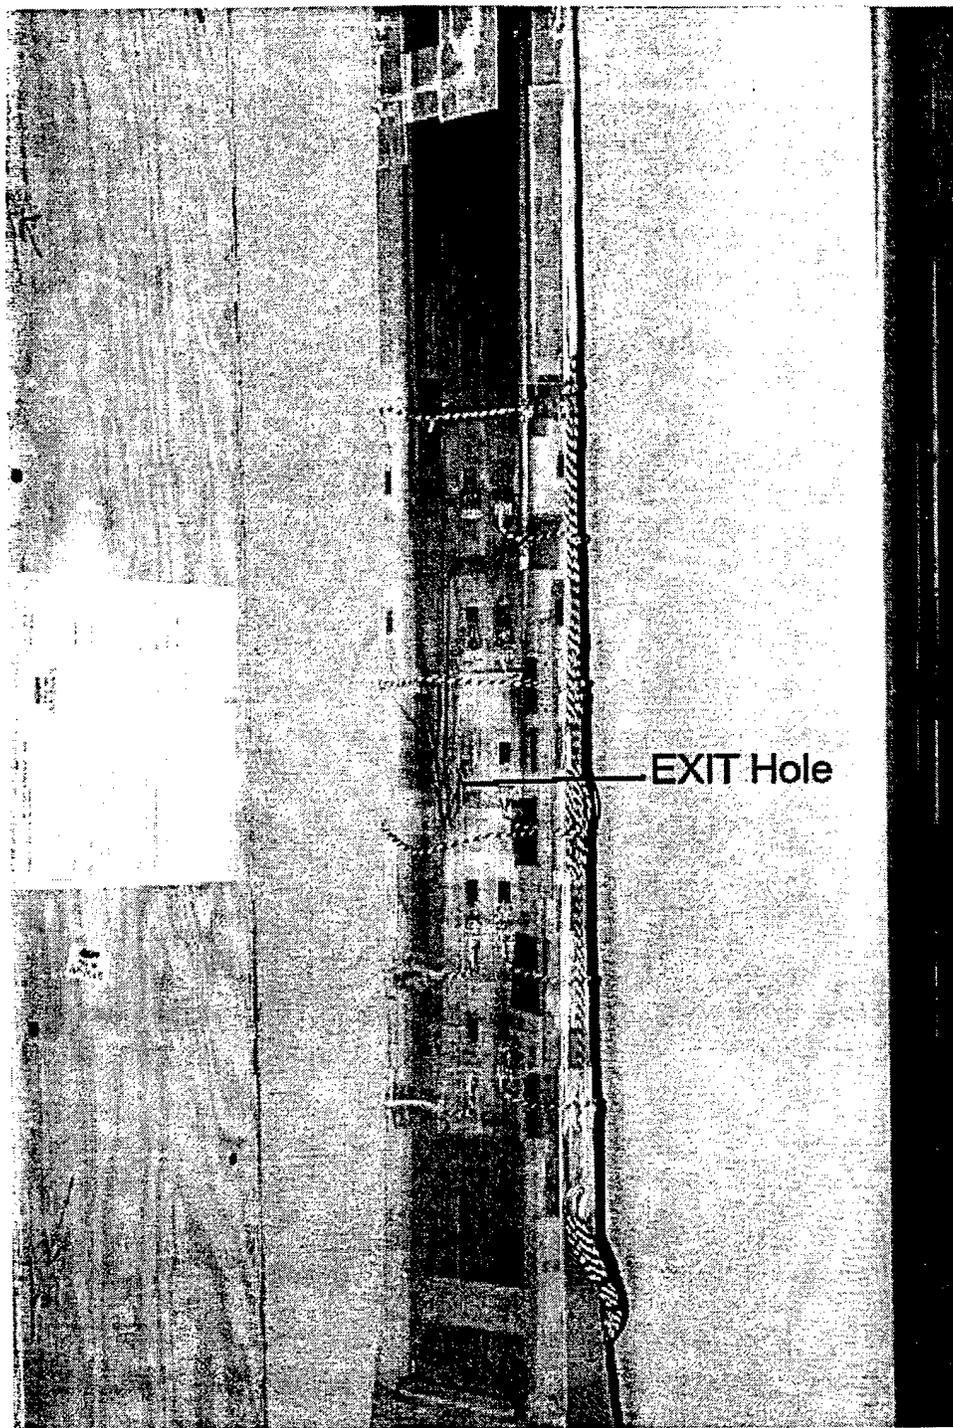
Figure 5 Ballistically Damaged Flexbeam Topside View

The ballistic damage of the S/N 0044 flexbeam is located at the inboard transition area. The projectile entered the flexbeam lower surface and exited through the upper surface approximately 13 inches from the root end, Ref. Figures 5 & 6. There was a heaping of delaminated and broken plys 1 inch tall, tapering down to 0.100" high, Ref. Figure 6. A crack extends from the center of the impact hole inboard 13" and outboard 17 1/2", Ref. Figures 8, 9 & 12.

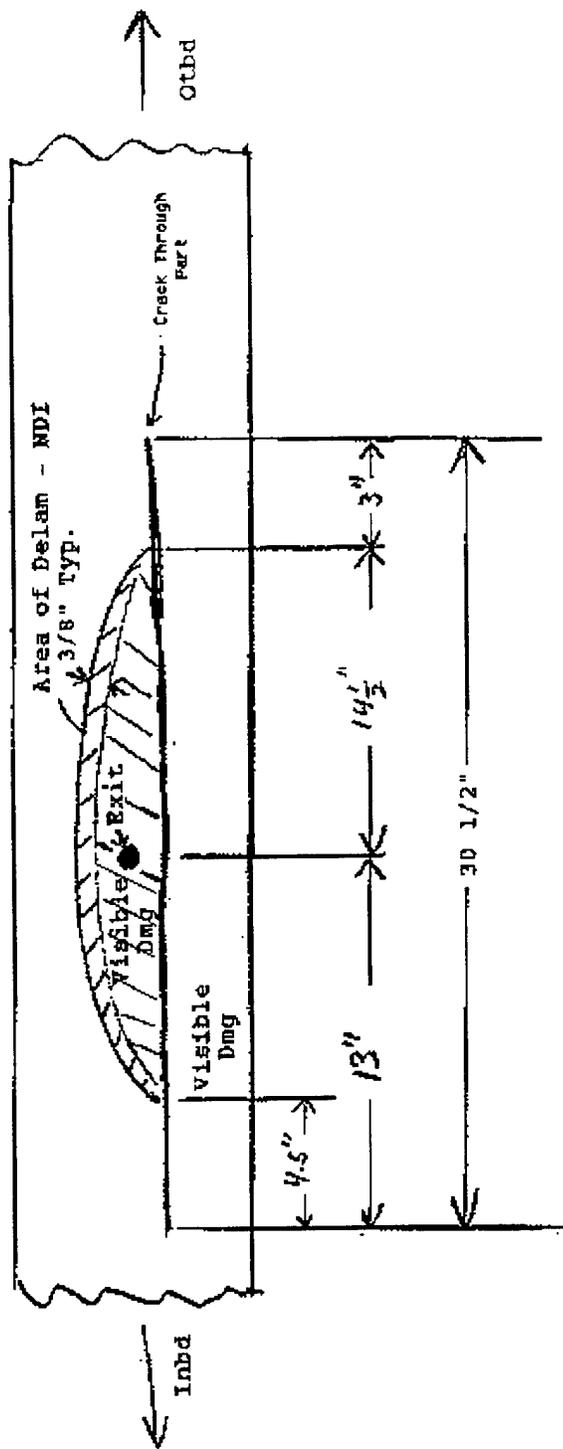
Figure 7 Damage Due to Impact

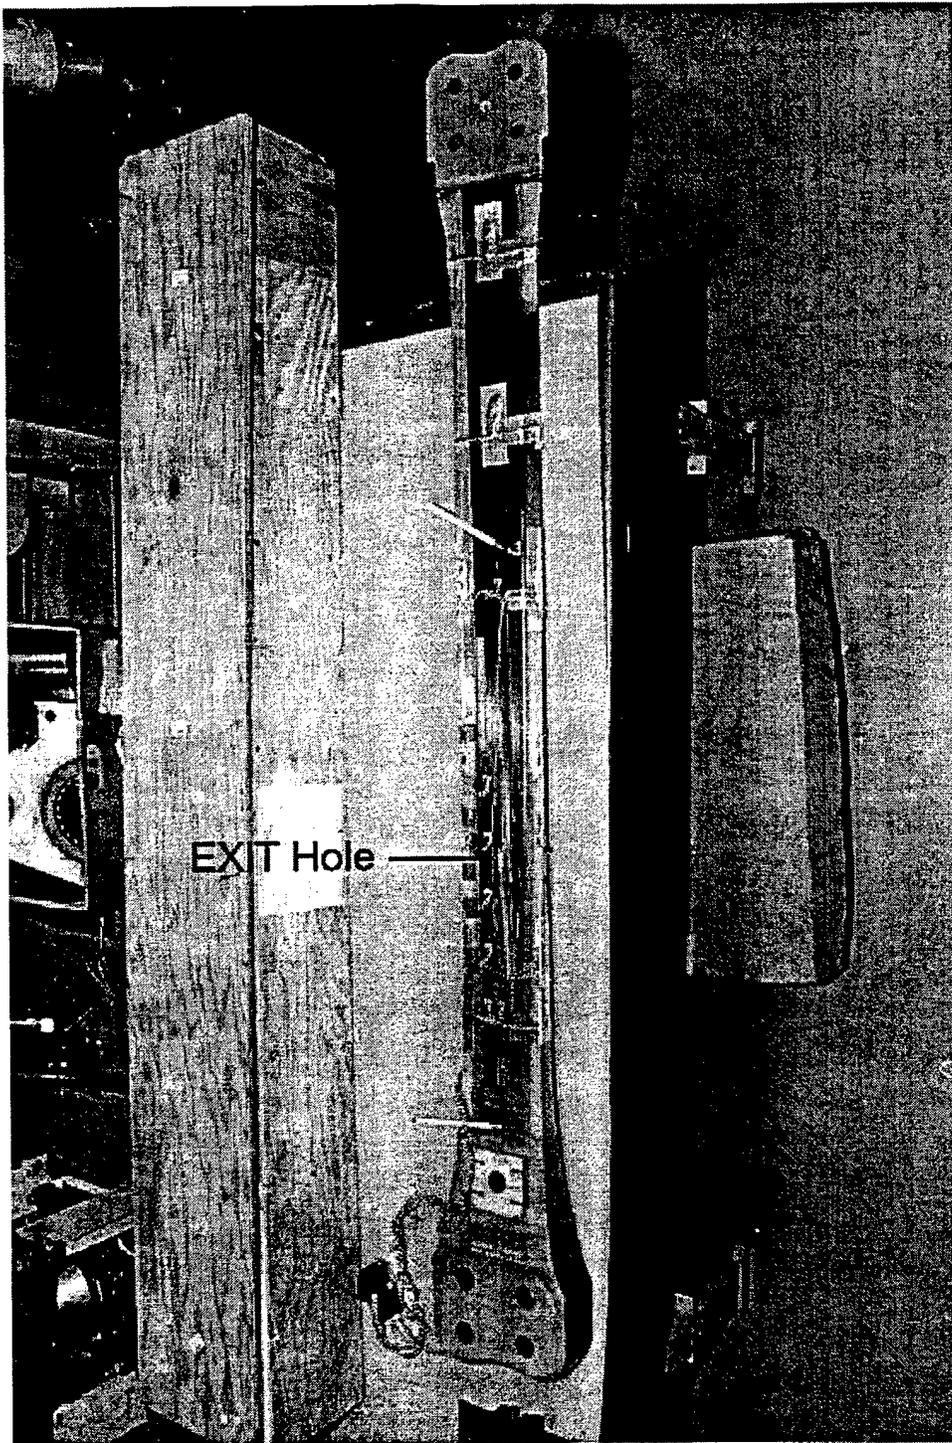
Figure 8 Ballistically Damaged Flexbeam Crack due to Impact Damage

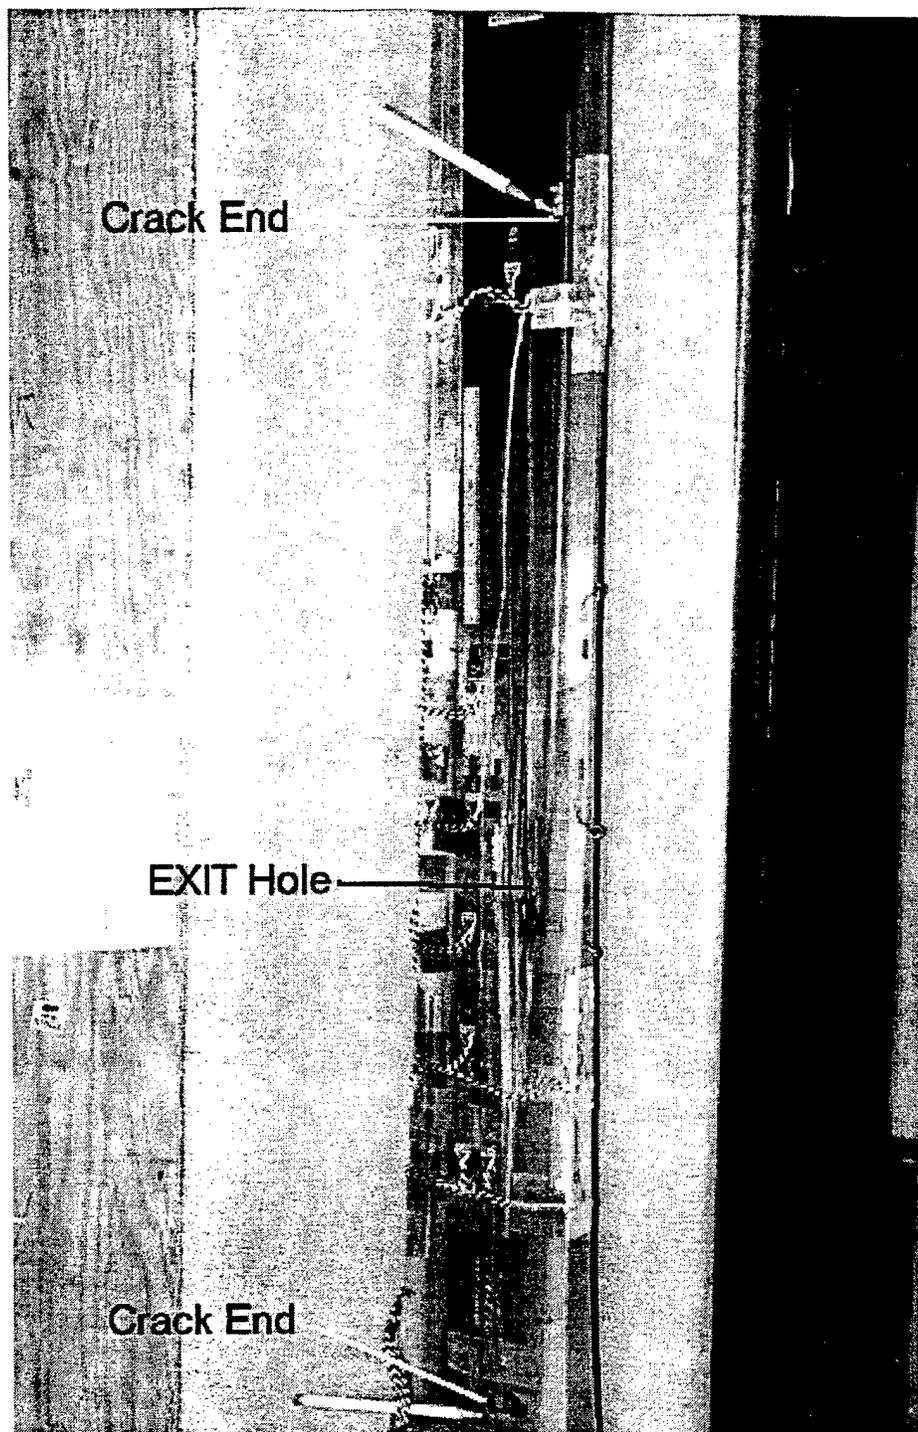
Figure 9 Ballistically Damaged Flexbeam Close-up View of Crack

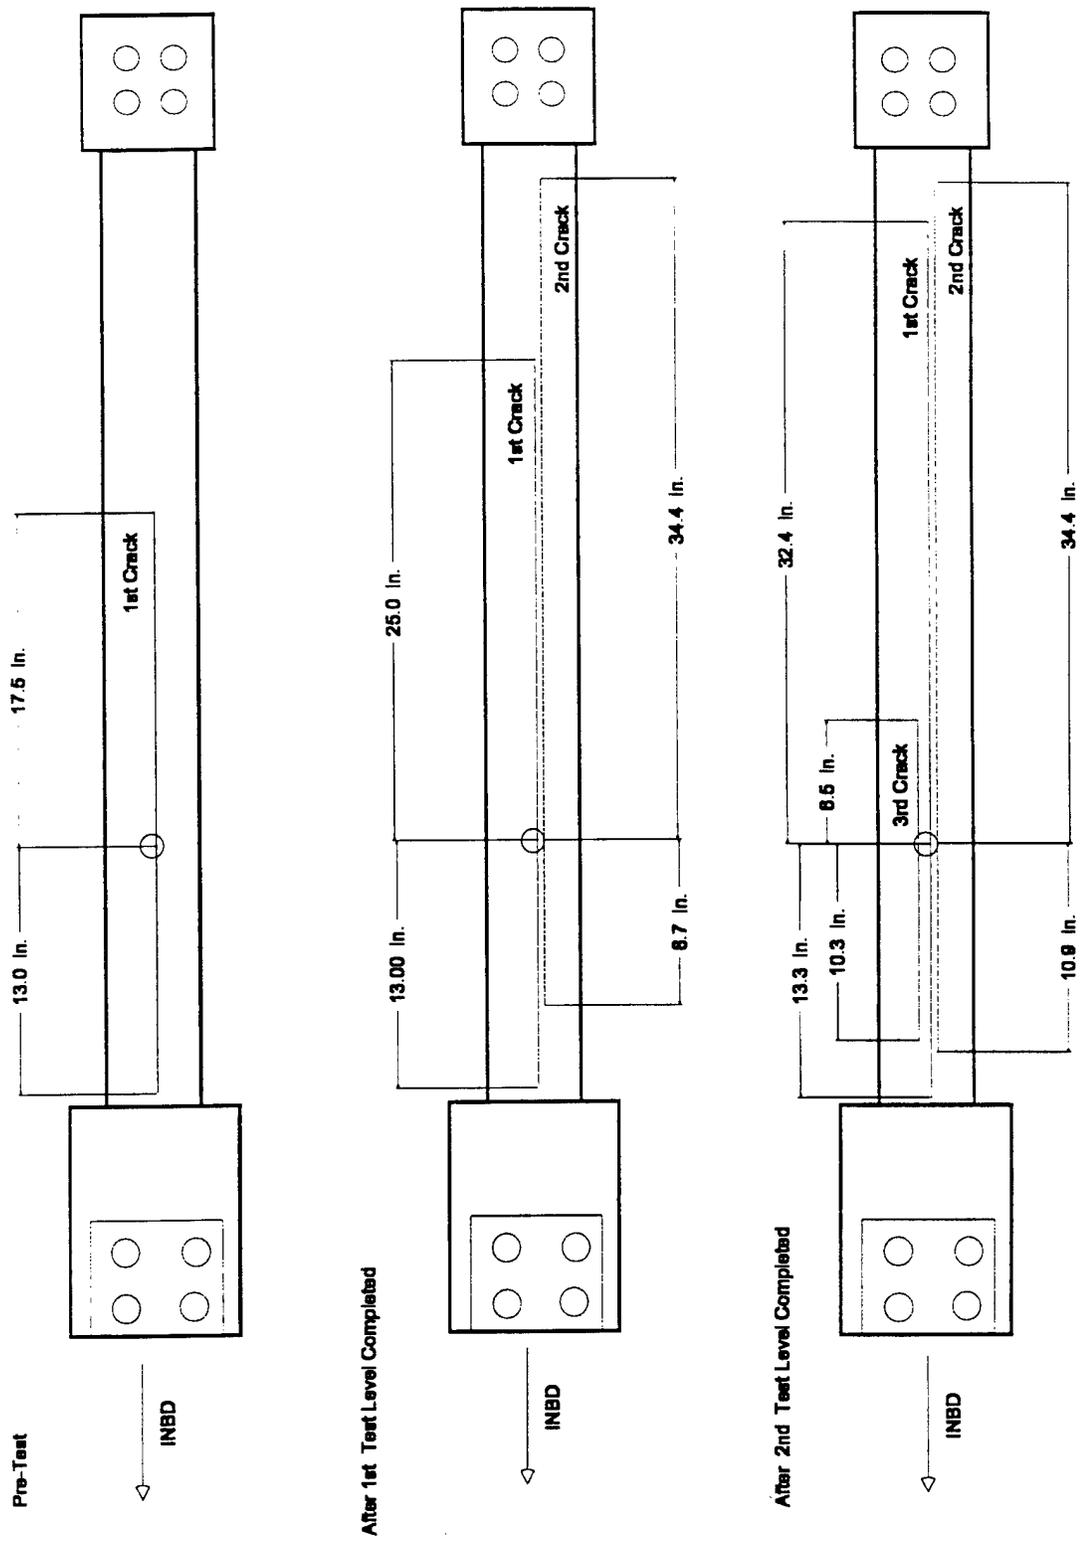
During the first test level, the crack propagated 7.5" outboard to a total length of 38". A second crack parallel to the first started and propagated 8.7" inboard and 34.4" outboard to a total length of 43.1"

During the second test level, the first crack propagated an additional 7.4" outboard and 0.3" inboard to a total length of 45.7". The second crack grew an additional 2.2" inboard to a total length of 45.3". A third crack started and propagated to 10.3" inboard and 6.5" outboard to a total length of 16.8".

Figure 12 Flexbeam Crack Propagation Sketch

A test or analysis to assess the change of dynamic response, and its stability impact, of the flexbeam due to ballistic damage and crack growth is recommended.

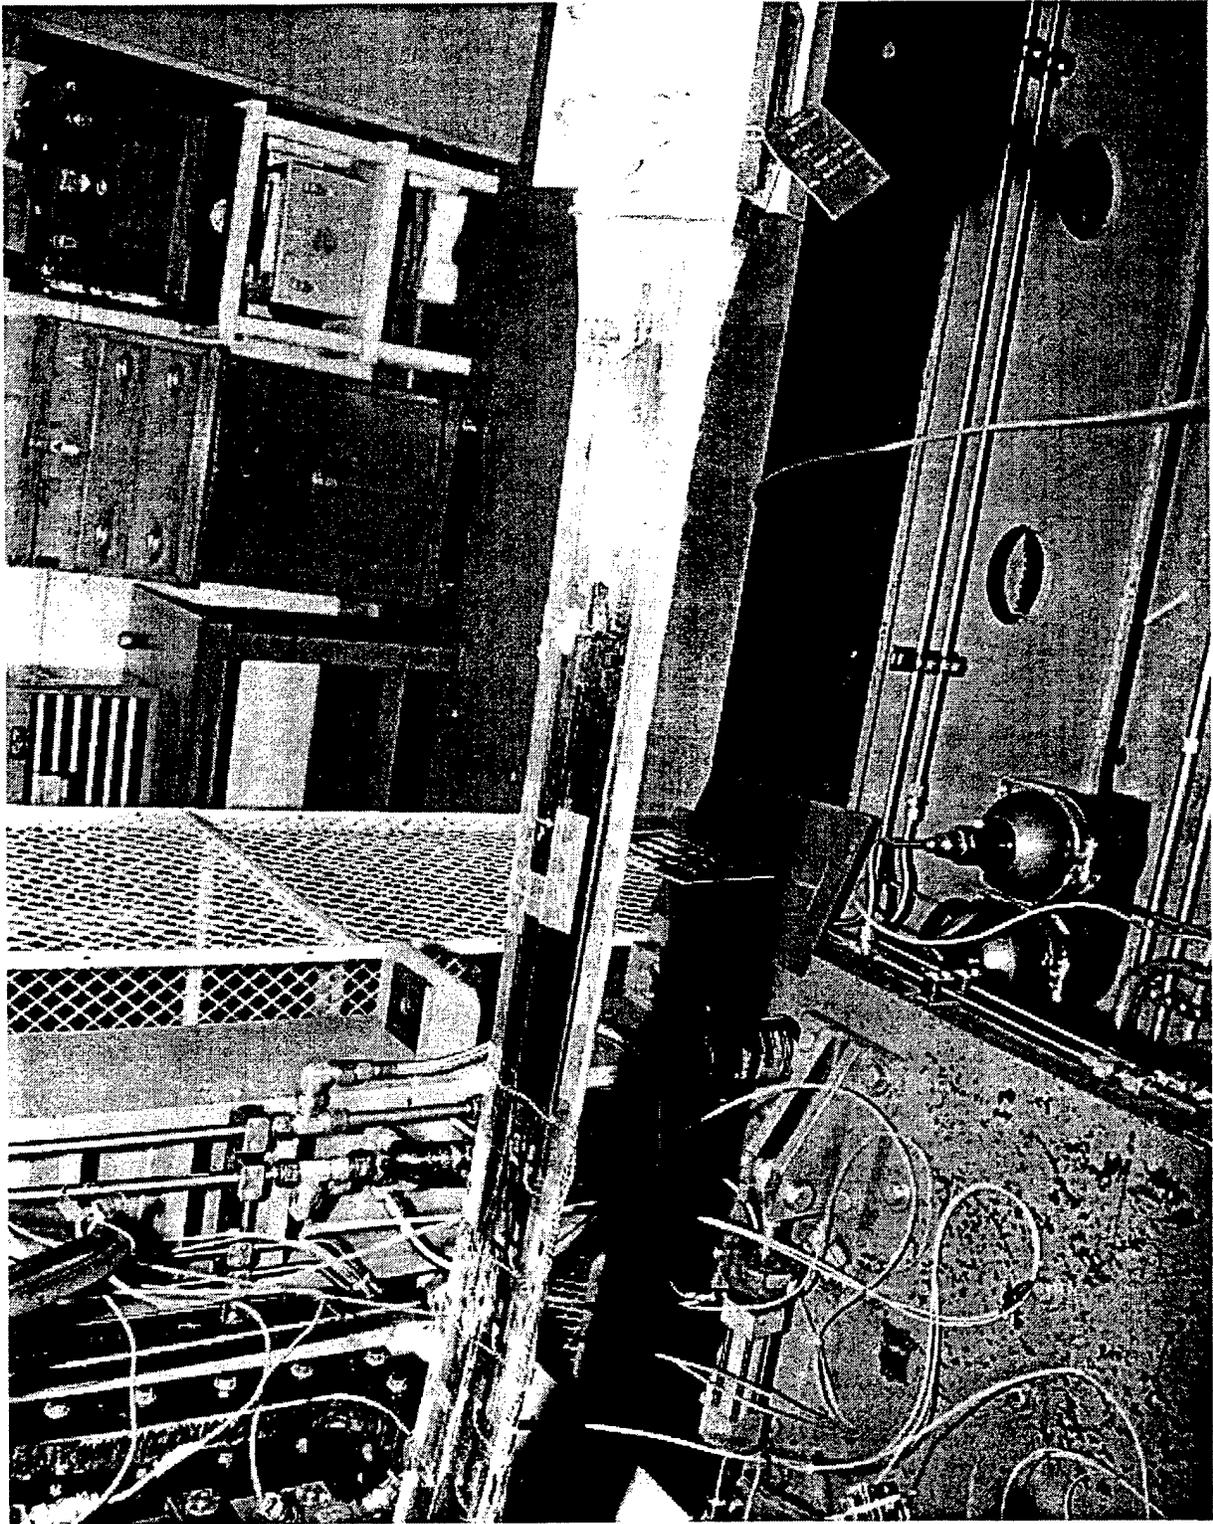
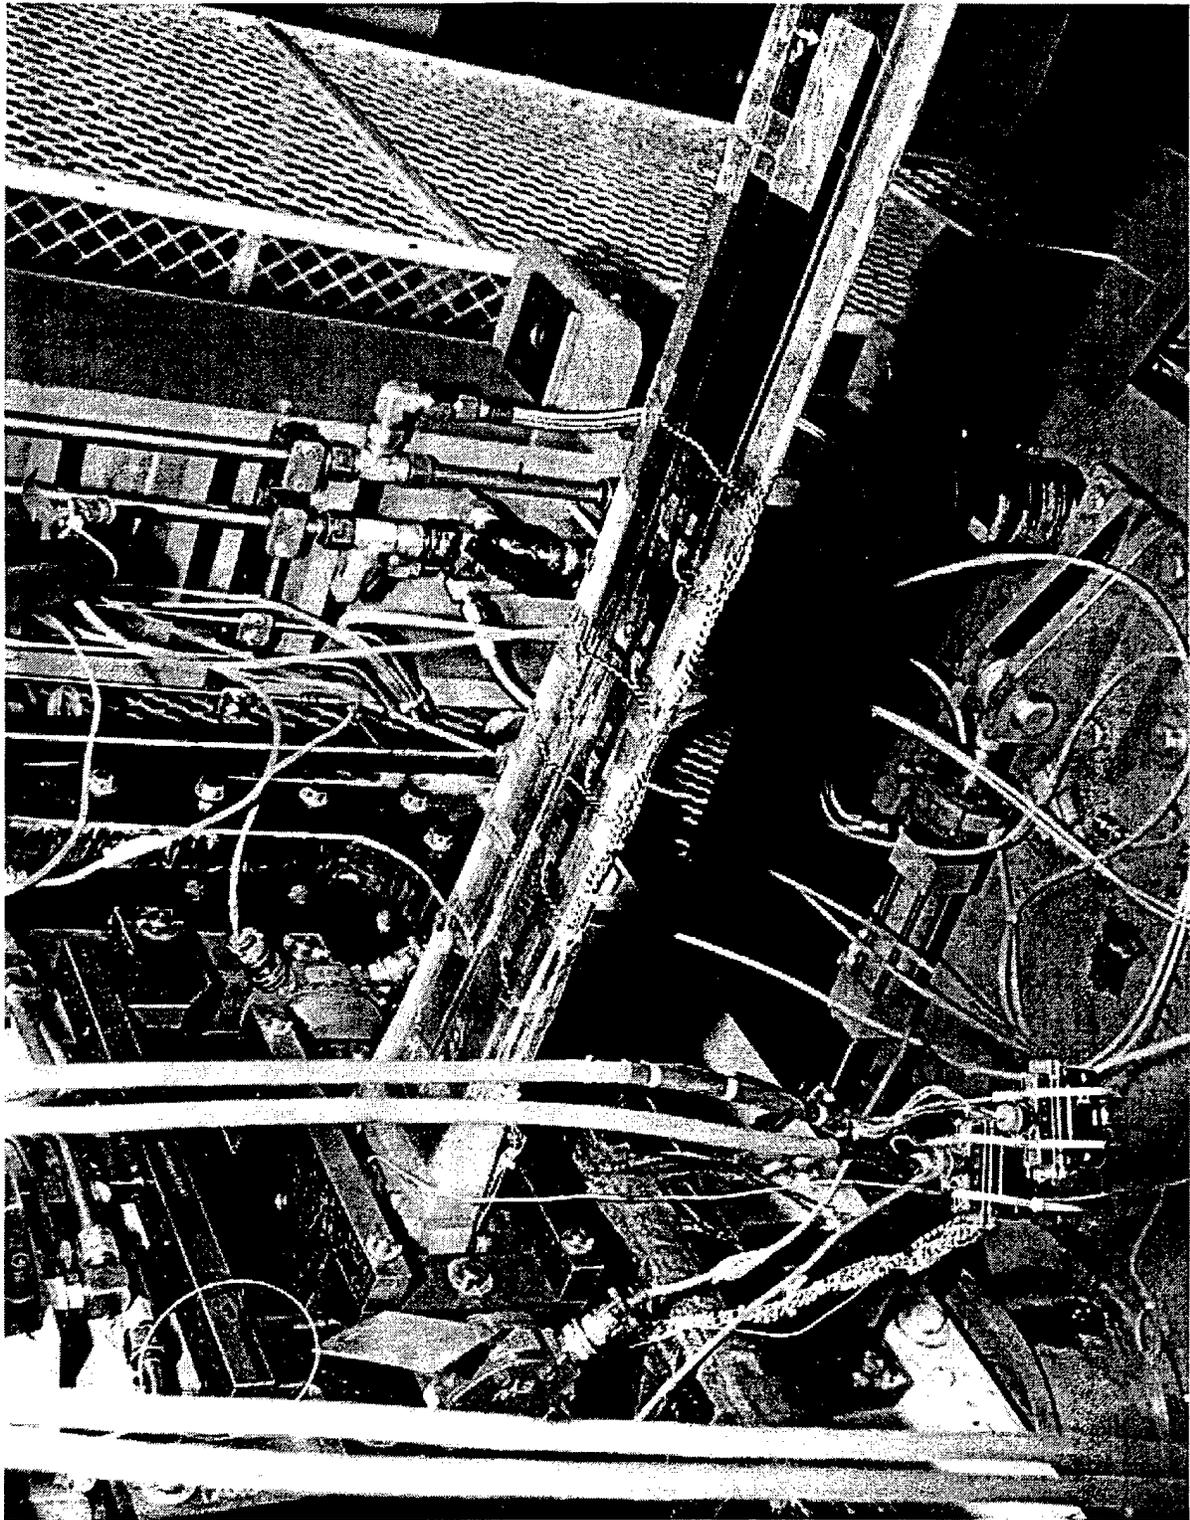
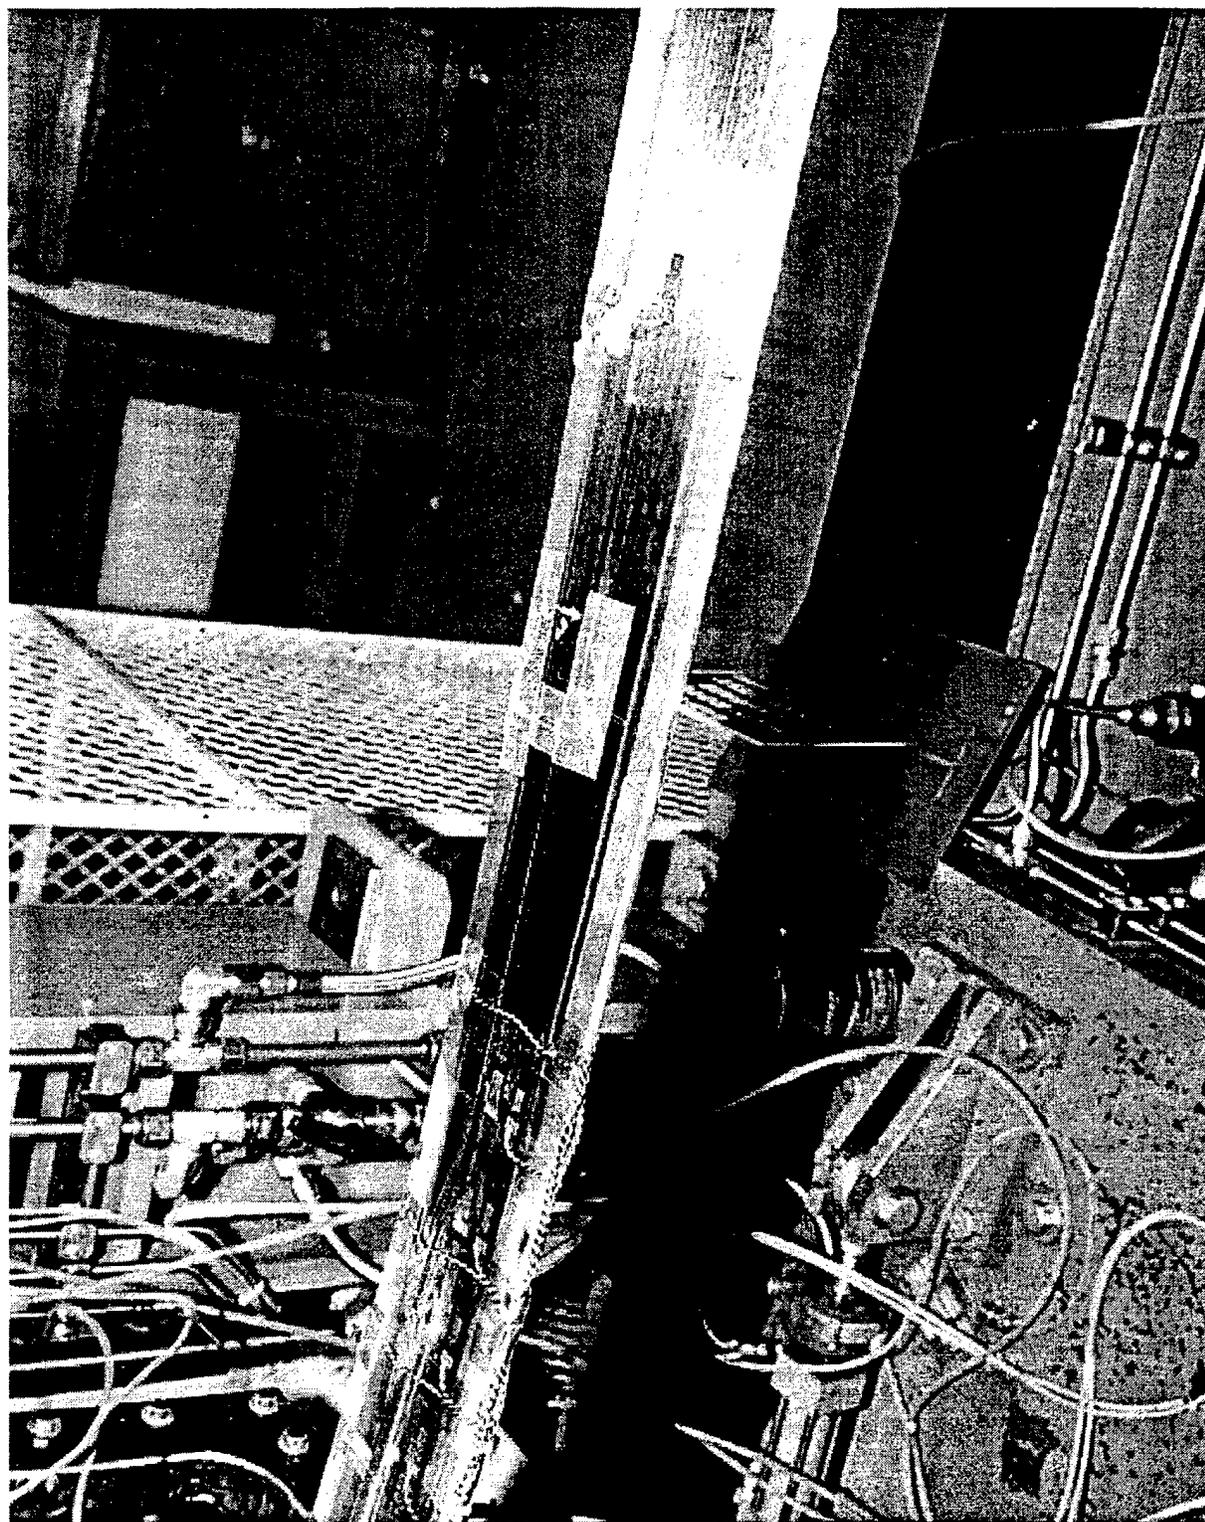
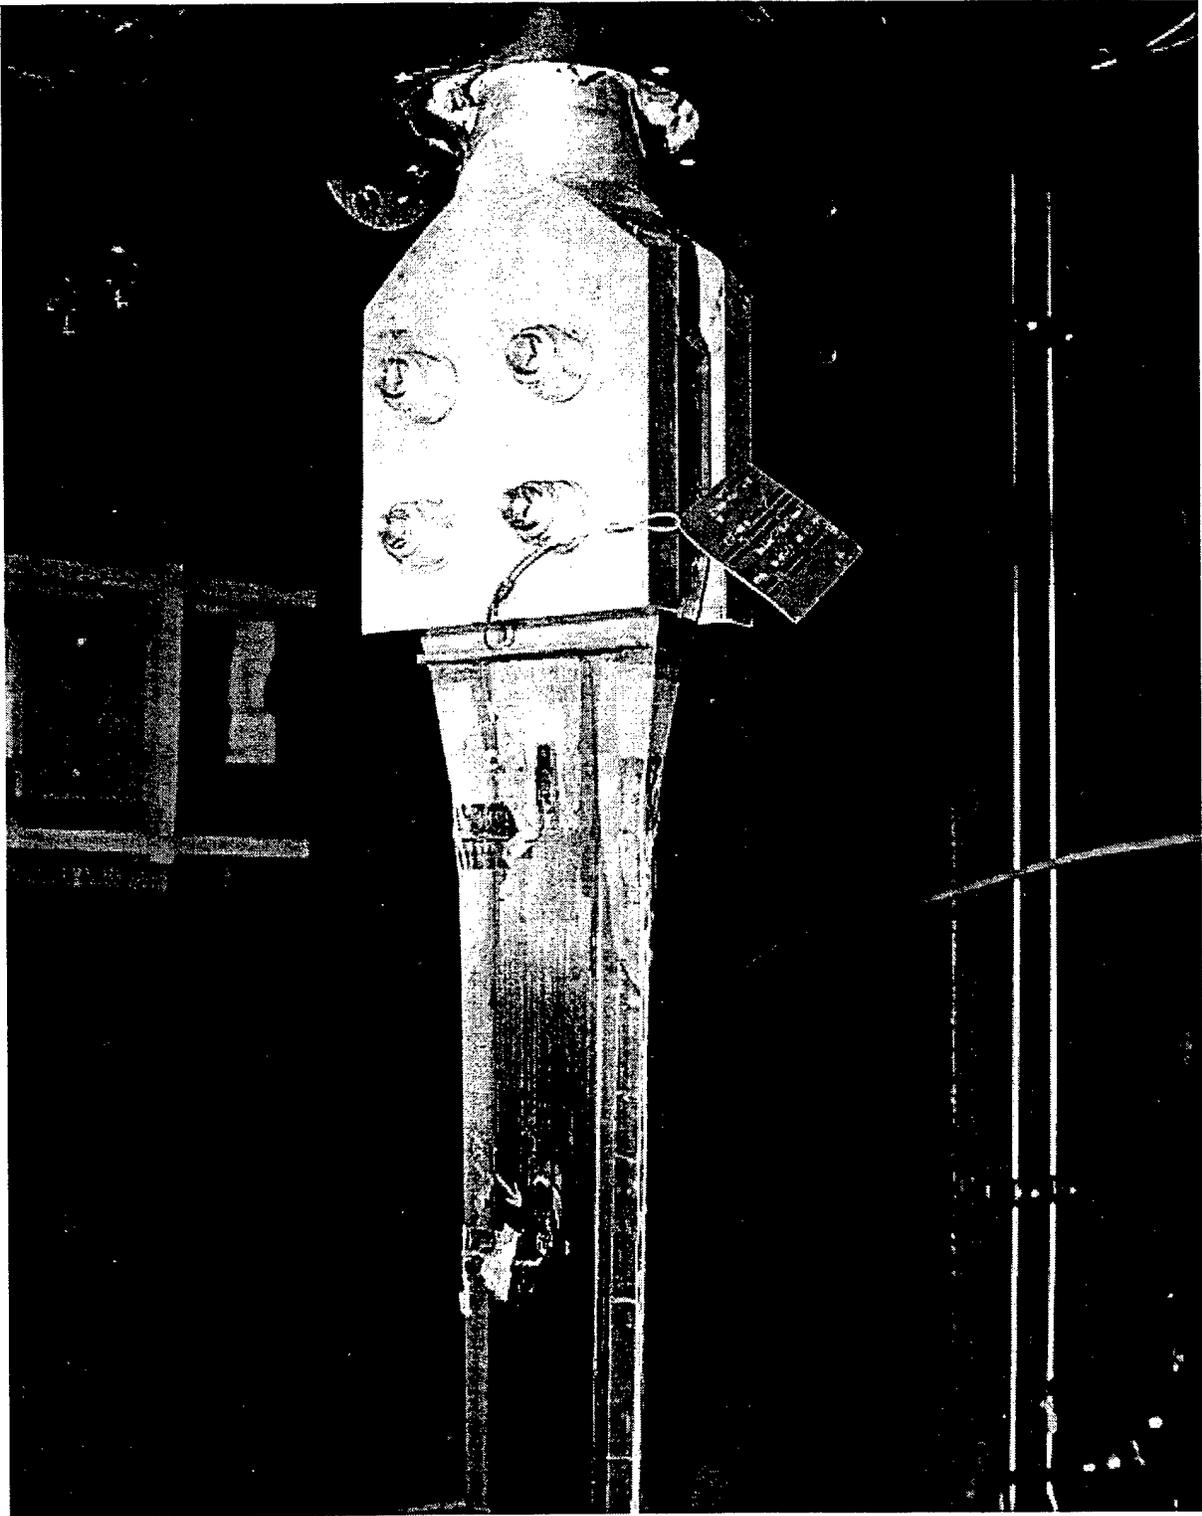
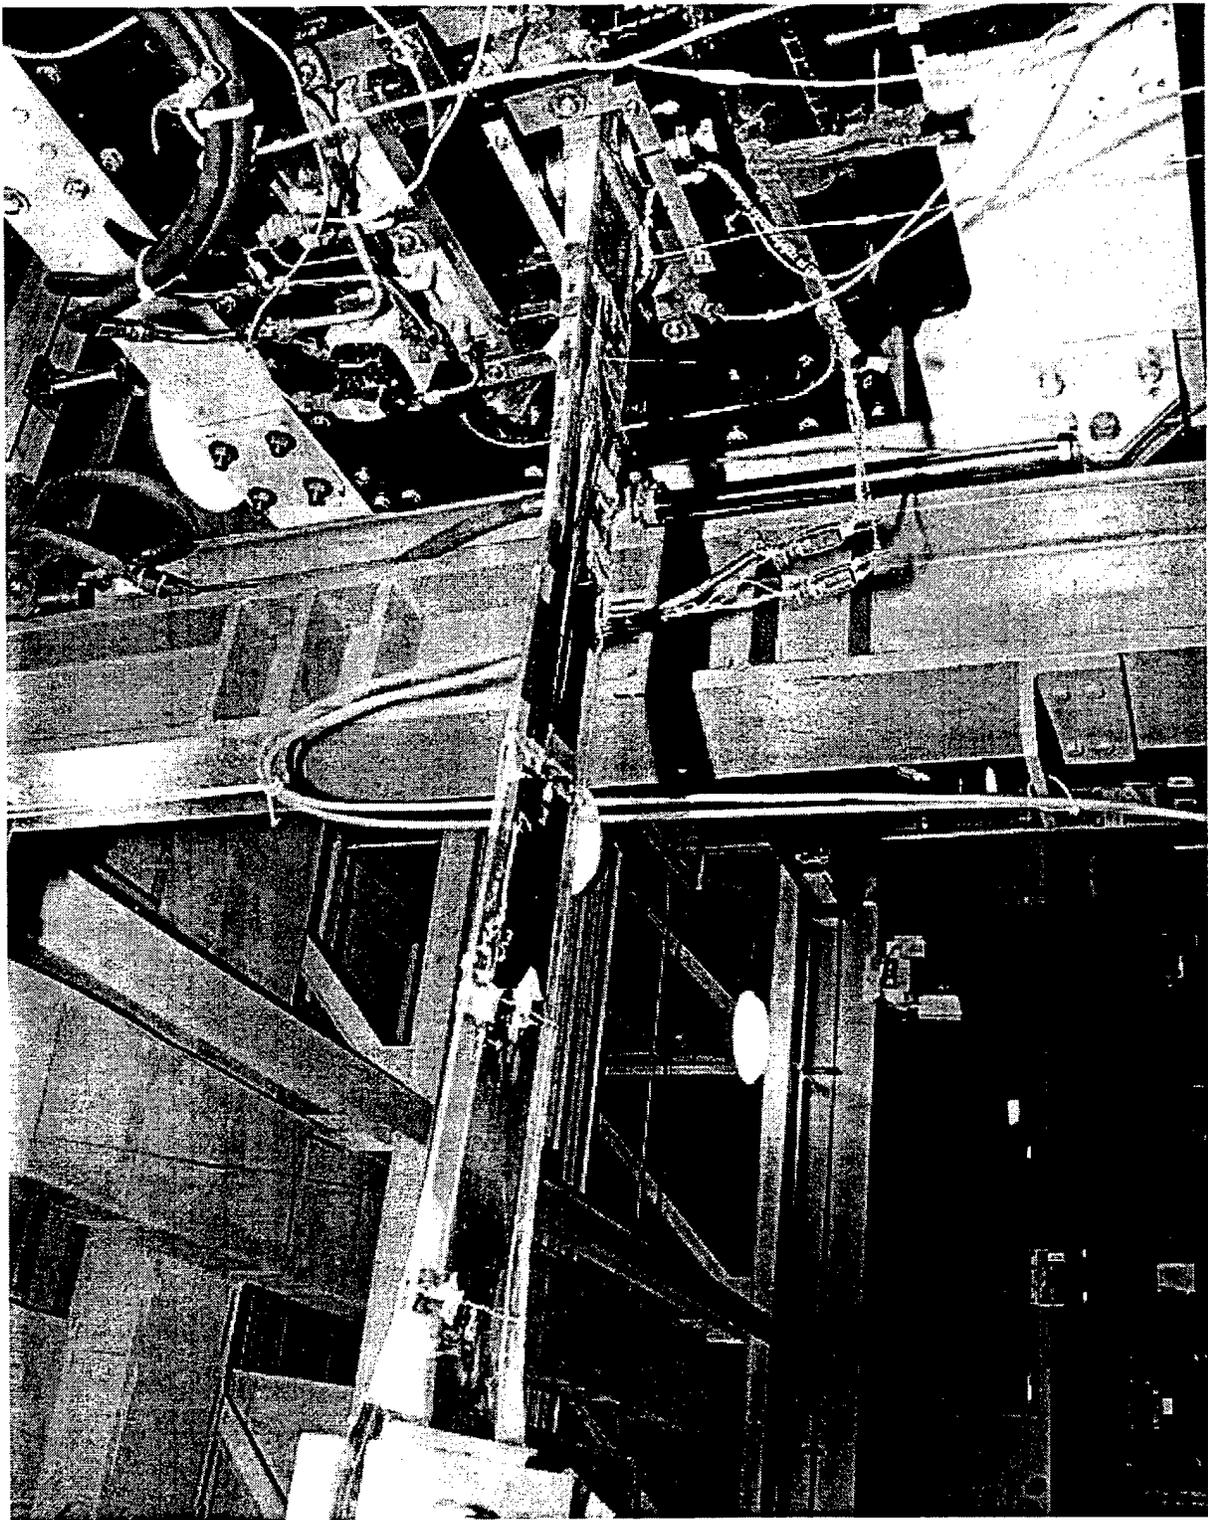
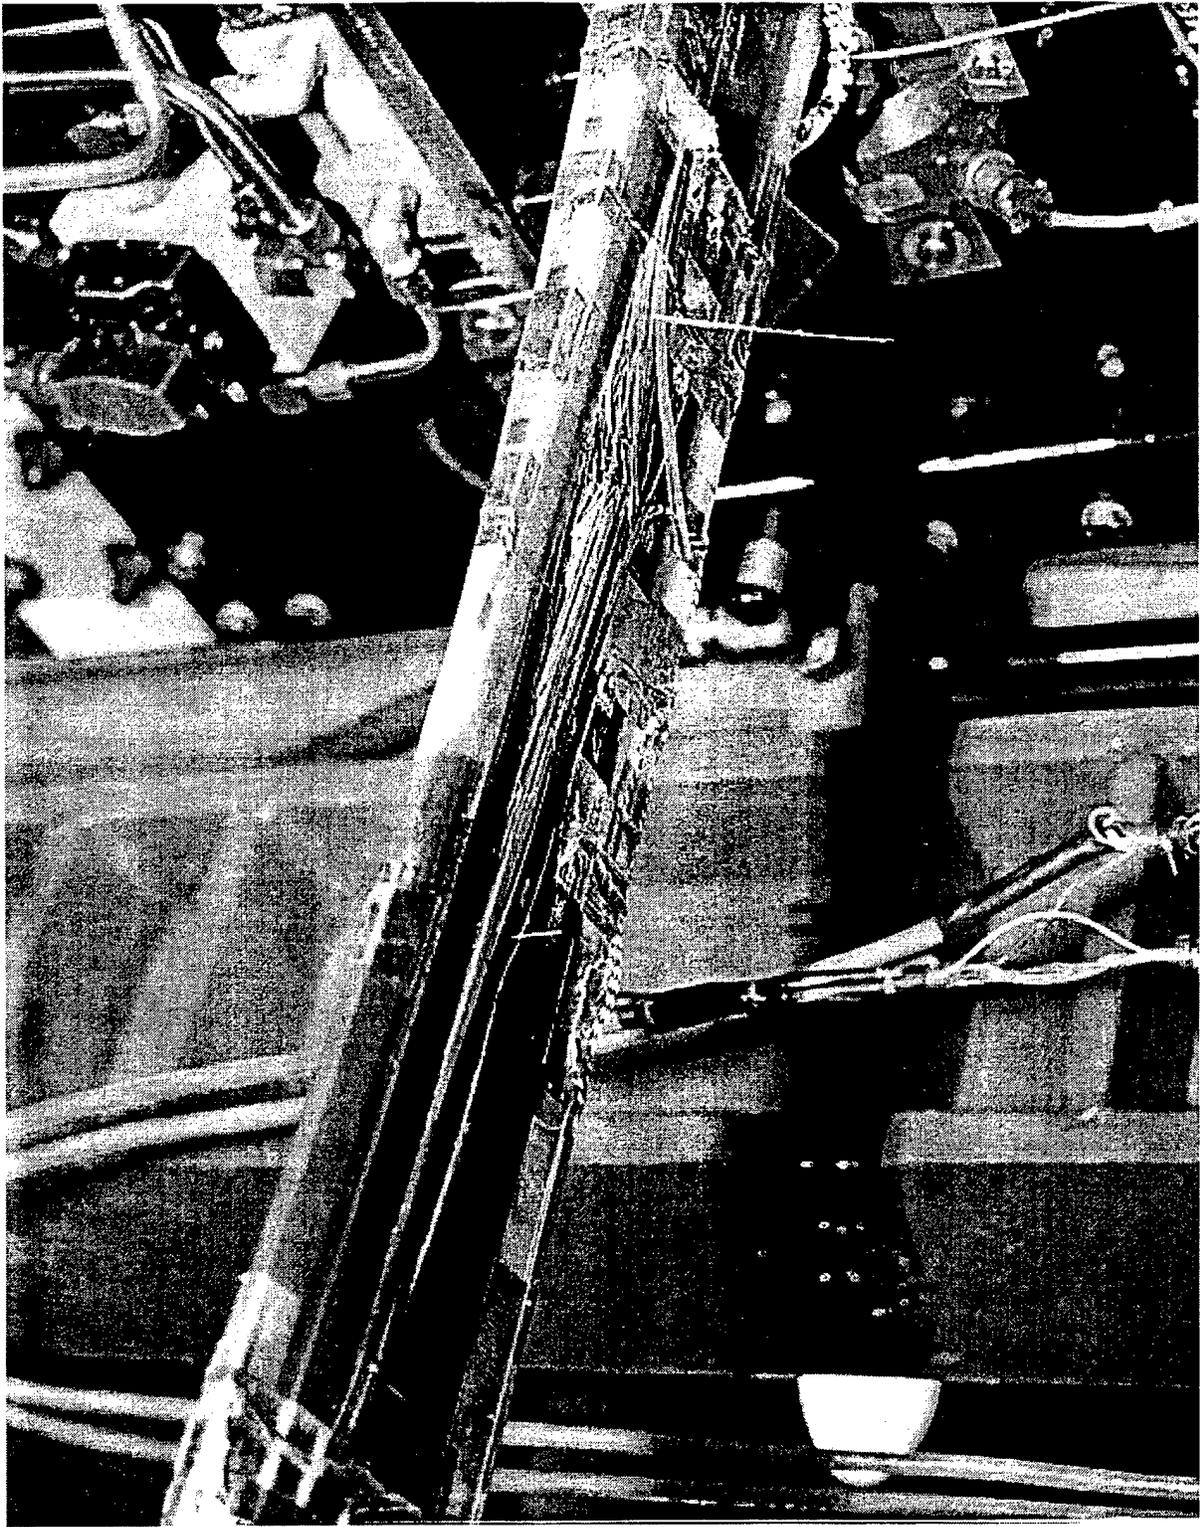
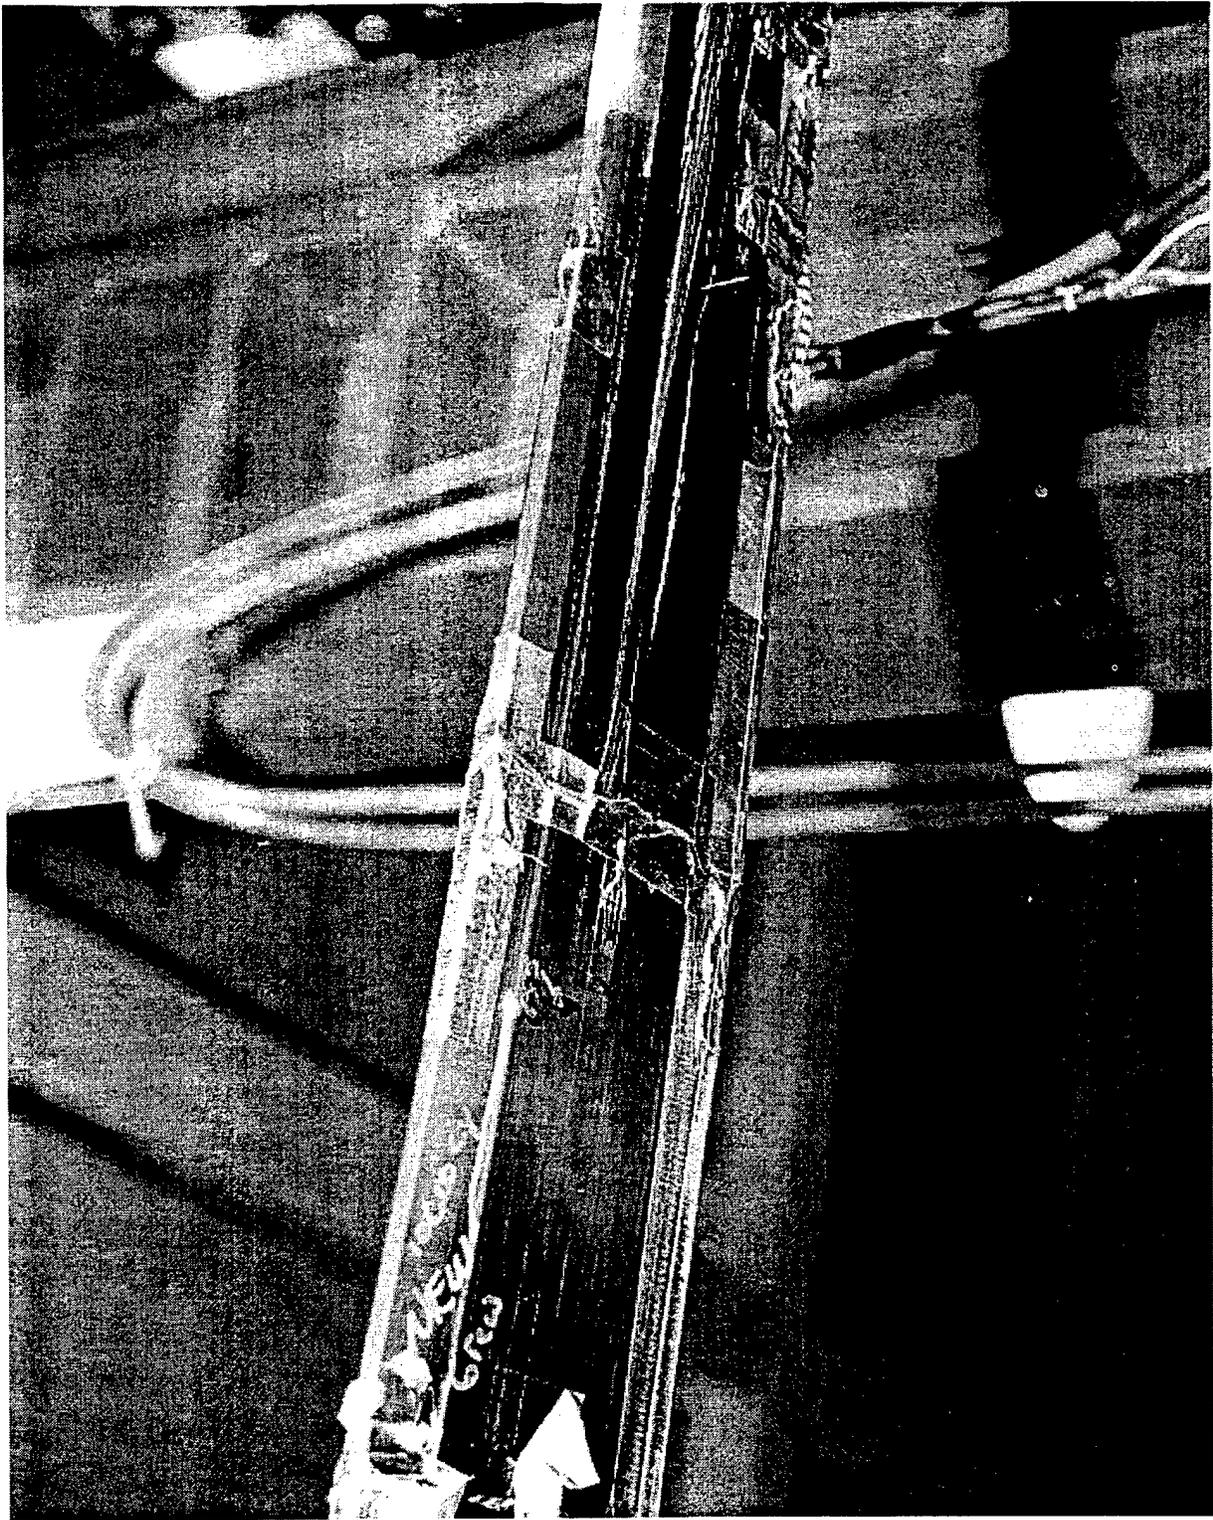
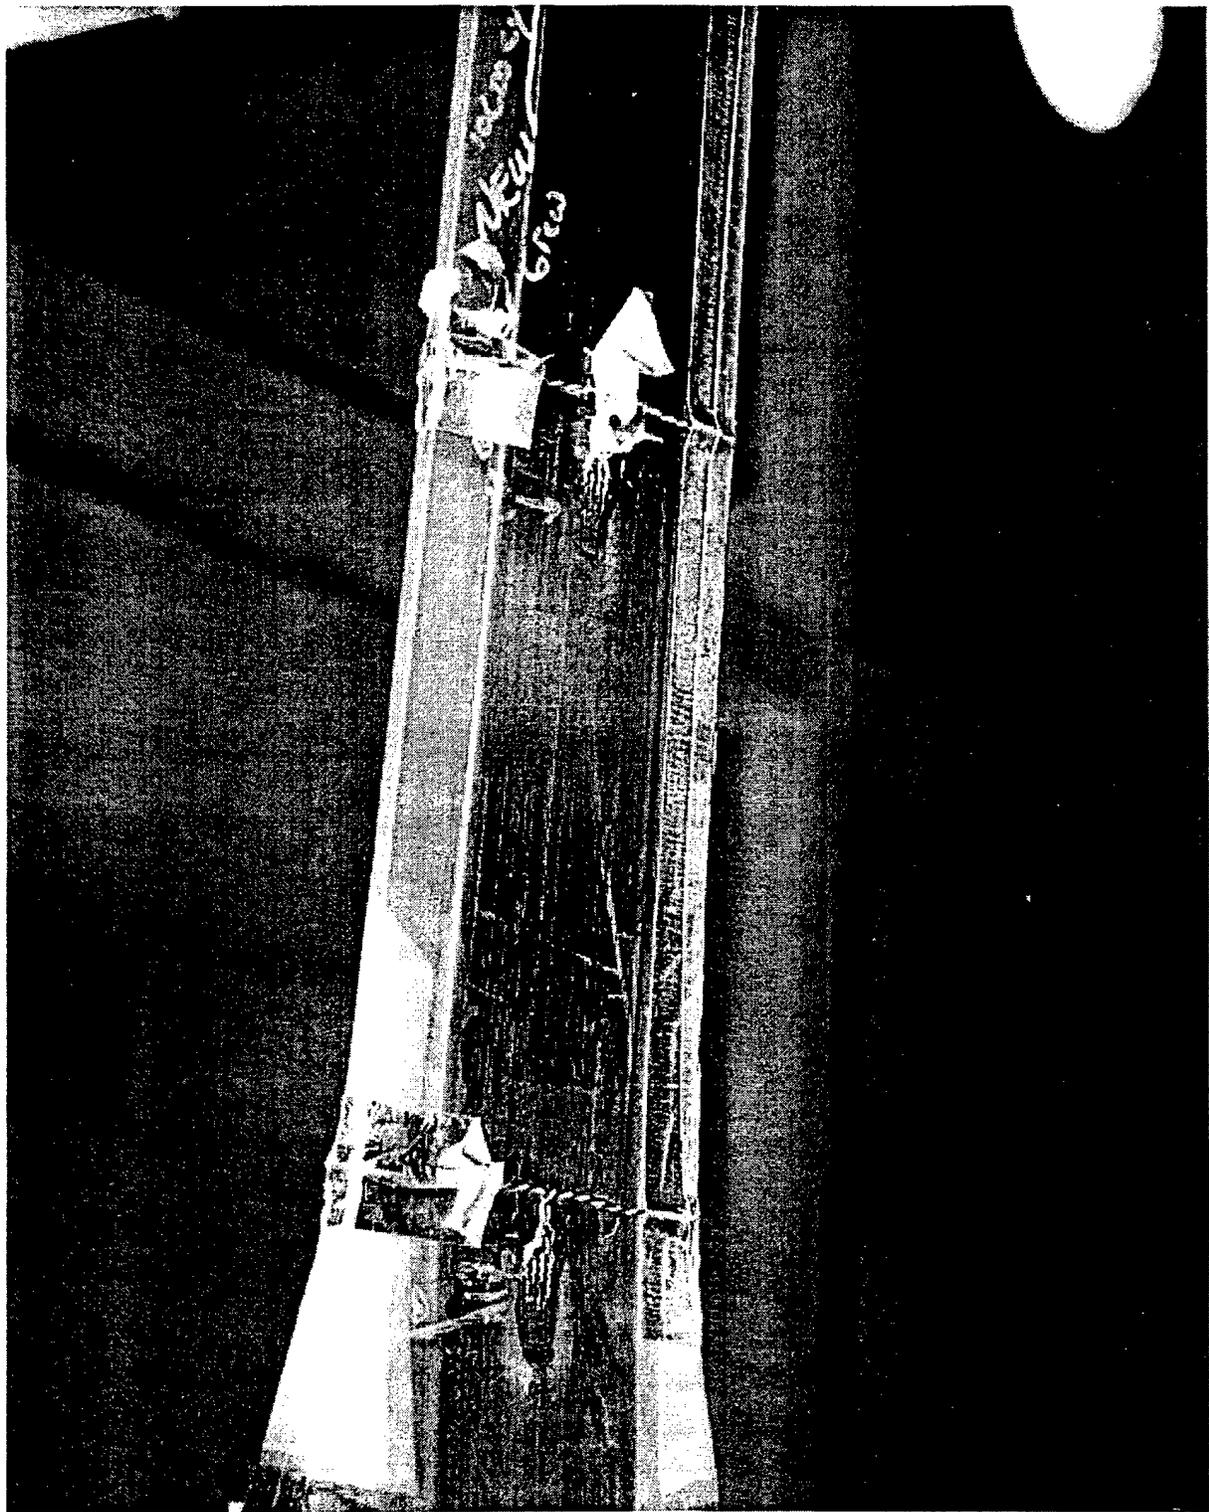
Pictures of Ballistically Damaged Flexbeam  
after Completing First Load Level Testing
